UNITED STATES AIR FORCE
ARMSTRONG LABORATORY

Wastewater Characterization Survey
Peterson, Falcon, and Cheyenne
Mountain Air Force Bases,
Colorado

September 1997

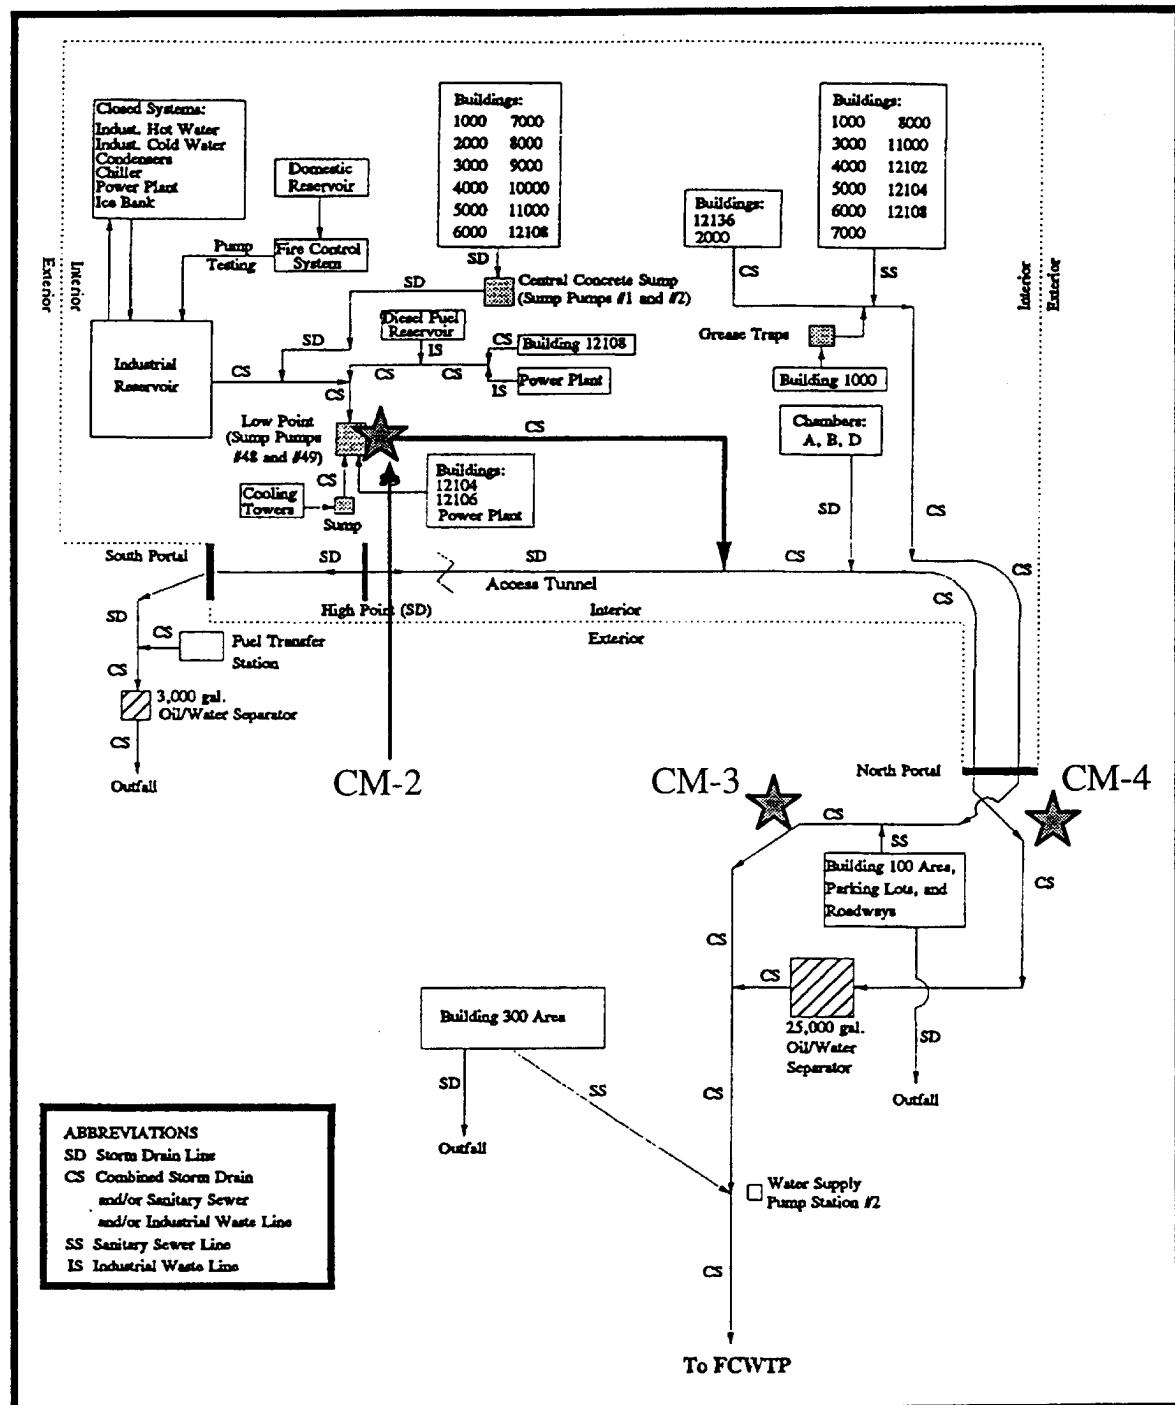
Figure 1
Cheyenne Mountain AFB Sampling Diagram
(CMAFB, Dec 1993)

Composite samples obtained from site CM-2 were collected internal to the mountain complex at the industrial waste sumps 48 and 49. Wastewater samples collected from this location (see figure 1) represent the light industrial activities interior to the Cheyenne Mountain complex. Samples were collected on 18 and 21 November 1995. Weak concentrations for COD, Oil and Grease, Total Petroleum Hydrocarbons, ammonia compounds, phenols, residue (solids), VOC's were observed. Glycol measurements for one sample were non-detect and the other sample recorded 591.97 $\mu\text{g/L}$.
